**Re: Metal Bank Cottman Avenue NPL Site
Monthly Report due June 10, 2013
Reporting Period: May 1 through May 31, 2013**

Project Name: Metal Bank NPL Site	For the Month: May 2013	
Project Location: Philadelphia, PA	Report Number: 86	Dated: June 10, 2013

Re: Report
Sheet Pile Wall Inspection
Metal Bank NPL Site
7301 Milnor Street
Philadelphia, PA 19136

This report is submitted in accordance with our agreement dated November 12, 2012. It covers our general understanding of the construction and purpose of the sheet pile wall at the referenced site. It also covers a visual structural evaluation of the sheet pile wall, identification of maintenance repairs and development of a monitoring plan.

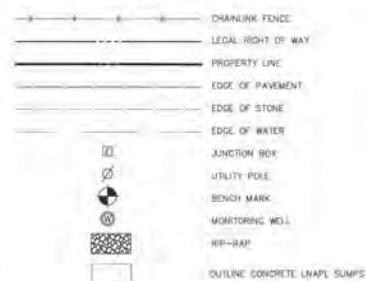
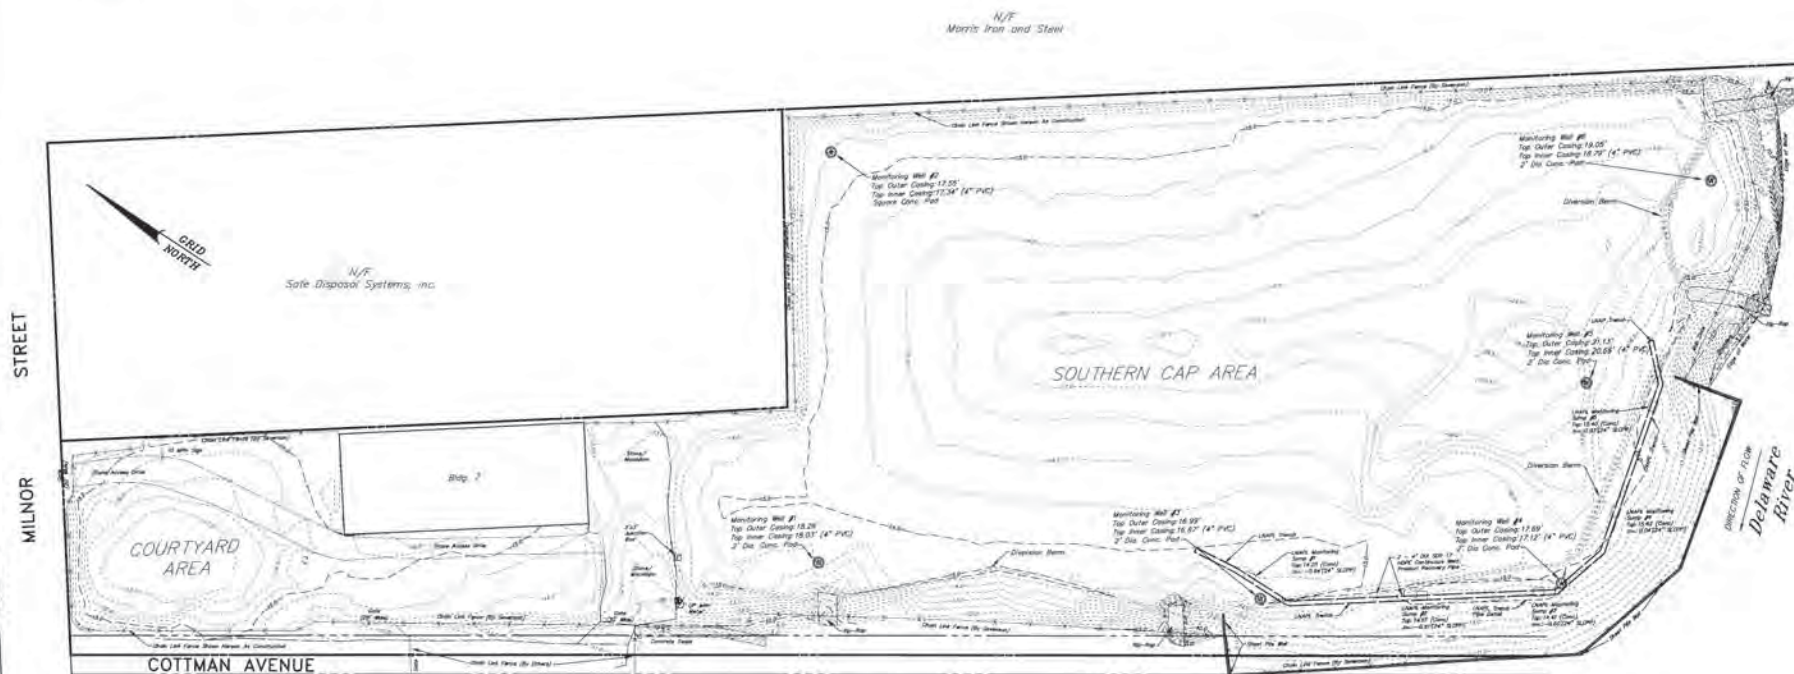
BY THIS SUBMITTAL, I HEREBY REPRESENT THAT I HAVE DETERMINED AND VERIFIED THE CONTOURS OF THE SOUTHERN CAP AREA AND THE COURTYARD AREA SHOWN HEREON AS OF JANUARY 19, 2010.
